## WEST BOUNDARY WALL REPAIR, ARLINGTON NATIONAL CEMETERY, ARLINGTON COUNTY, VIRGINIA

John H. Haynes, RPA  
U.S. Army Corps of Engineers, Norfolk District  
June 2015

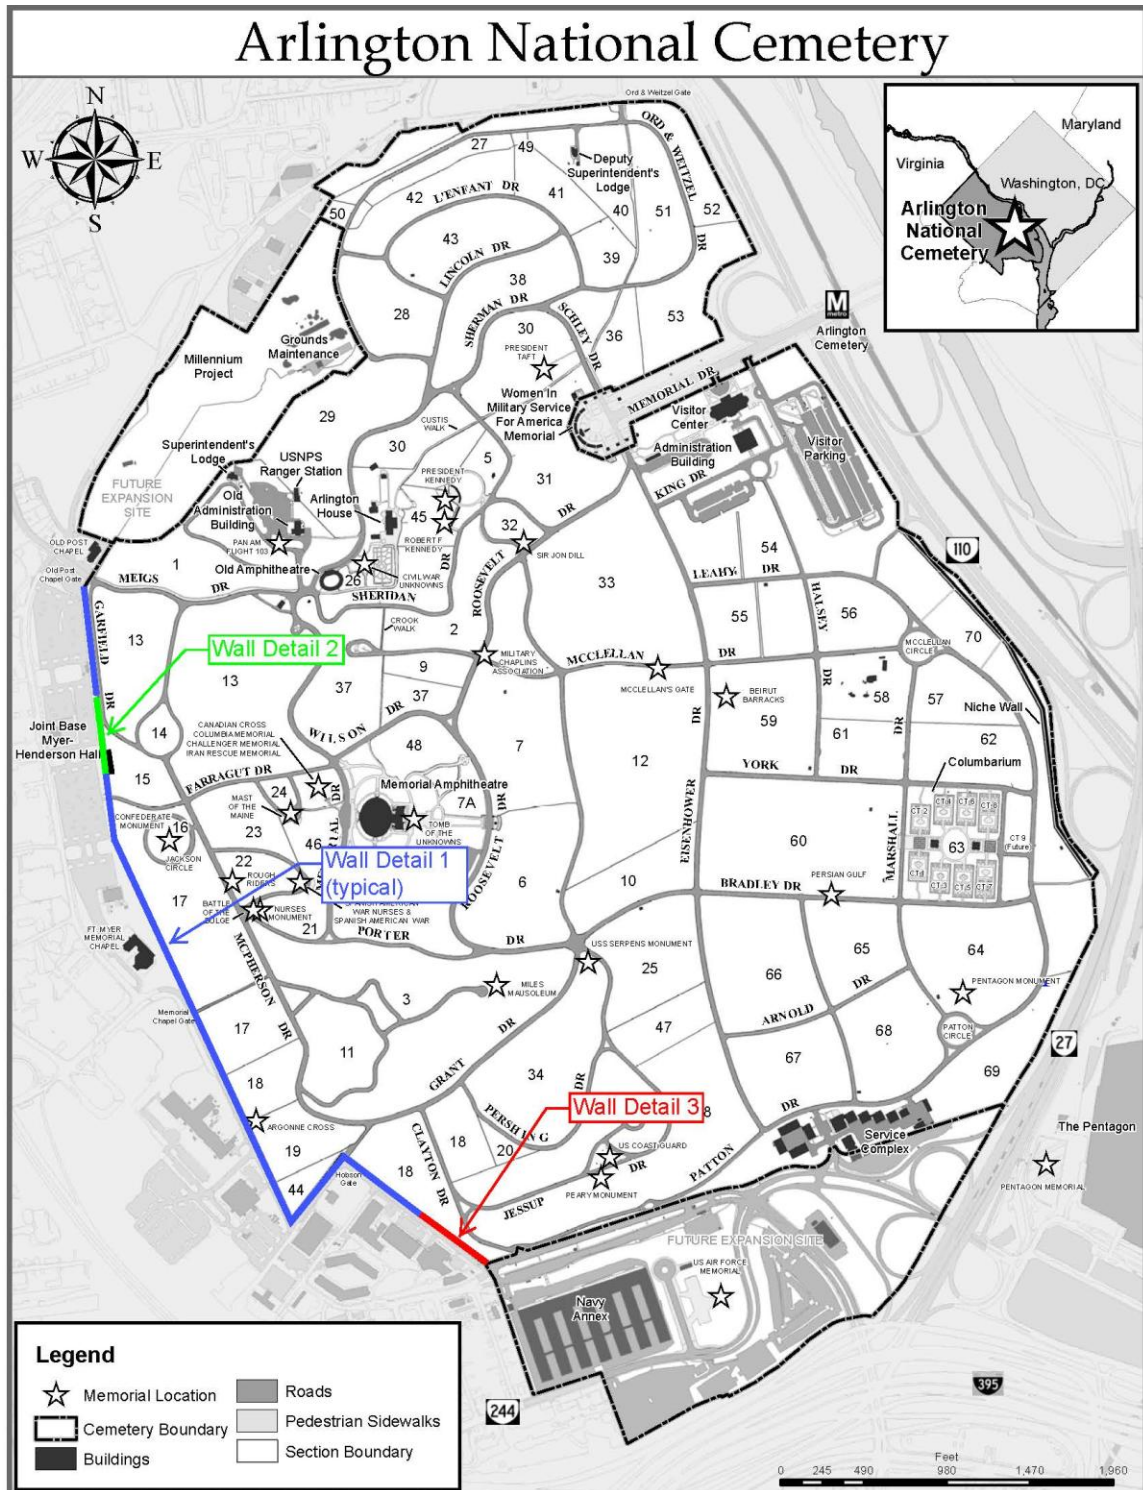
Figure 15 - Areas for Wall Reconstruction Types

This project dismantles the wall on the western perimeter of ANC, constructs a concrete footing and in some areas a partial concrete core. The U.S. Army Corps of Engineers, Norfolk District (NAO) identified areas for wall reconstruction based on the difference in grade between the ANC and JBM-HH sides of the wall (Figure 15).

- Type 3 (Figure 18). This will be used in a 264.5 foot section of wall extending from a point opposite Henderson Hall to the southern end of the cemetery (Figure 15). This design type is similar to Type 2. The difference is the height of the reinforced concrete core. Type 3 will be used at areas where the grade between the two sides of the wall is greater than 4 feet. This option uses salvaged stone to reconstruct the top of the wall.
